ONE KATUN OF WAIT AT EL MIRADOR, PETÉN: EXPLORATION AND RE-EXCAVATION OF STRUCTURE 34 FROM THE LATE PRECLASSIC

Richard D. Hansen
Enrique Monterroso Tun
Antonieta Cajas
Adriana Linares
Carlos Morales

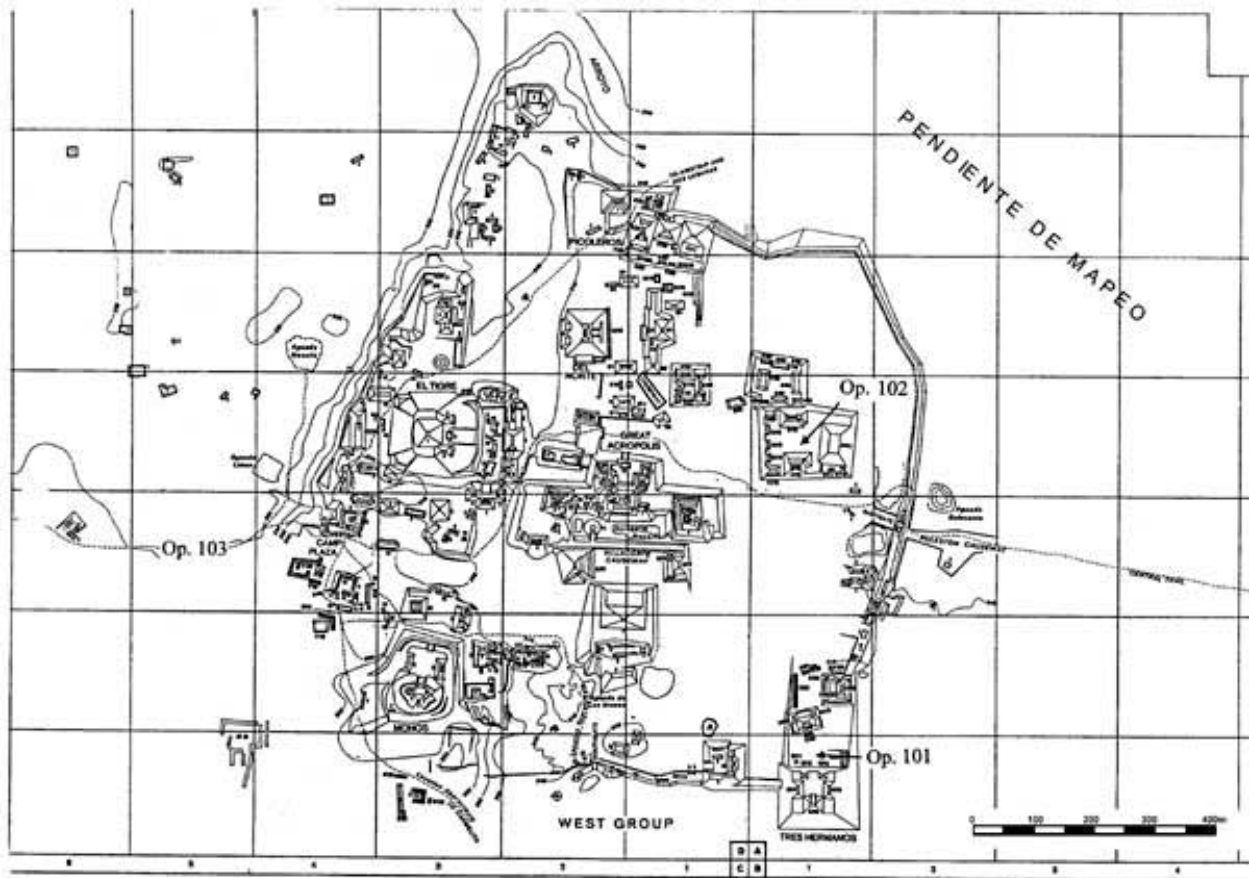
Figure 1. Map of El Mirador (Dahlin 1984), showing the areas where the explorations took place.

The archaeological excavations at El Mirador during the field season 2003 included test pits and the intensive excavation of several plazas and structures, represented by Operations 101, 102 and 103 (Figure 1). The excavation of Operation 101, supervised by Adriana Linares, determined that the complex of large buildings with a triadic pattern denominated the Tres Micos complex, located on the southeast corner of the Western Group, is also dated to the Late Preclassic period. The ceramic recovered from the stratigraphic levels of test pits has indicated an occupation exclusive of the Late Preclassic period (Figure 2a).

Figure 1 Map of El Mirador (Dahlin 1984) showing the areas where the explorations took place.

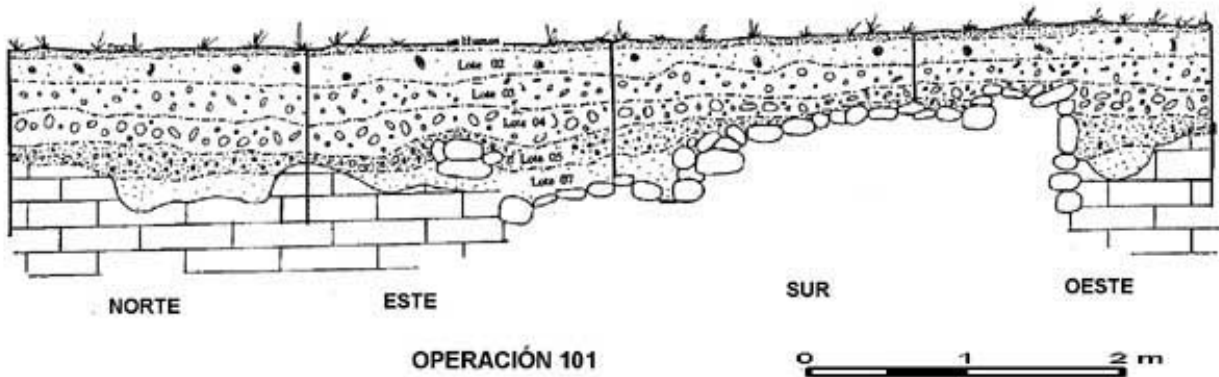
Figure 2a. Profile of Operations 101 and 102 (drawing by A. Linares and C. Morales).

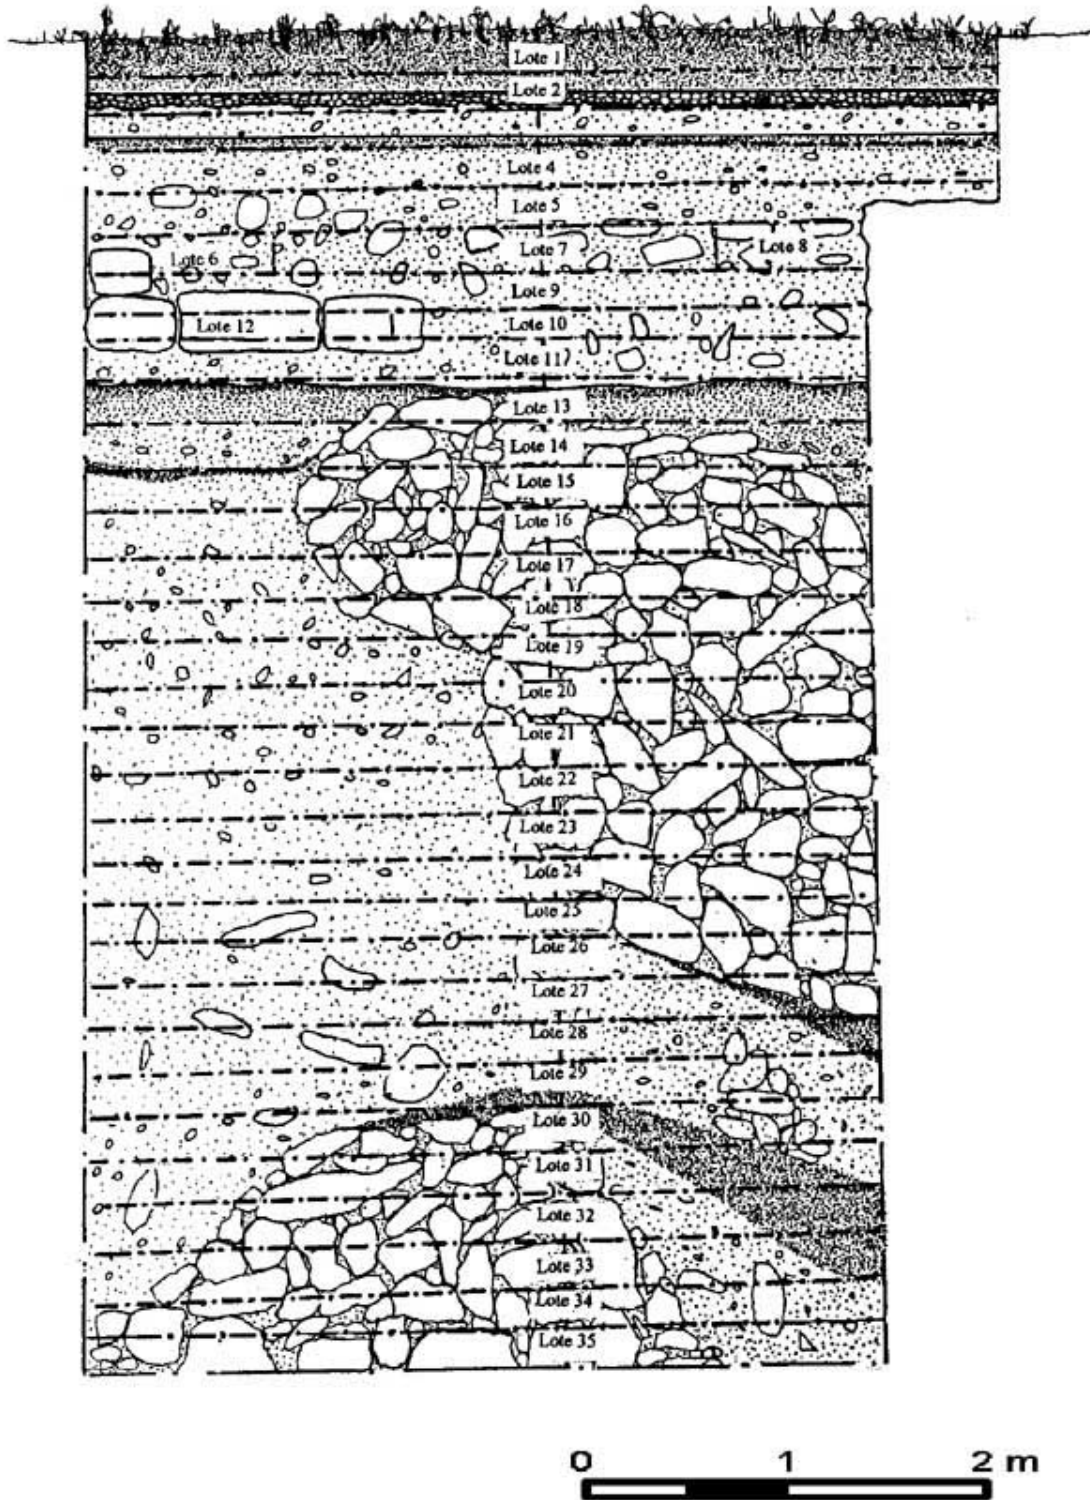
Figure 2b. Profiles of Operations 101 and 102 (drawing by A. Linares and C. Morales).

Operation 102, conducted at the complex of Las Cigarras, was in charge of Carlos Morales, achieving a depth of 7 m in the refill, and uncovering one stucco and two *sascab* floors, as well as several construction cells, which suggested a work control and some remarkable architectural construction programs exclusive of the Late

Preclassic period, as determined in previous investigations in other sectors of the site (Figure 2b).

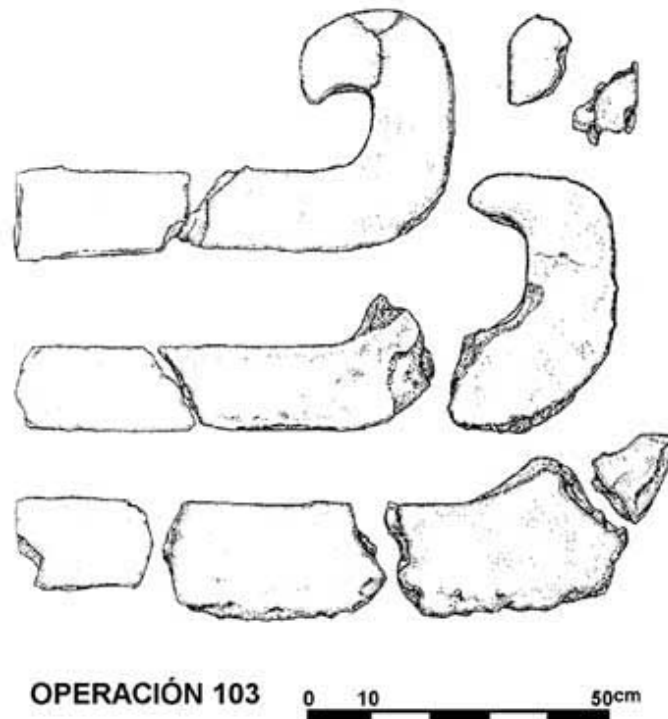
Figure 3a. Artifacts found in Operation 103 (drawings by Sharon Belkin).

The excavations conducted in Operation 103, supervised by Antonieta Cajas, revealed the complexity of the site regarding its settlement pattern. This excavation took place at the west scarp of the Western Group of the site, within the camp area. The scarp is 30 m high and surrounds the west and north sides of the Western Group. A preliminary excavation led to the recovery of two scrolls in the shape of a J (Figure 3a),

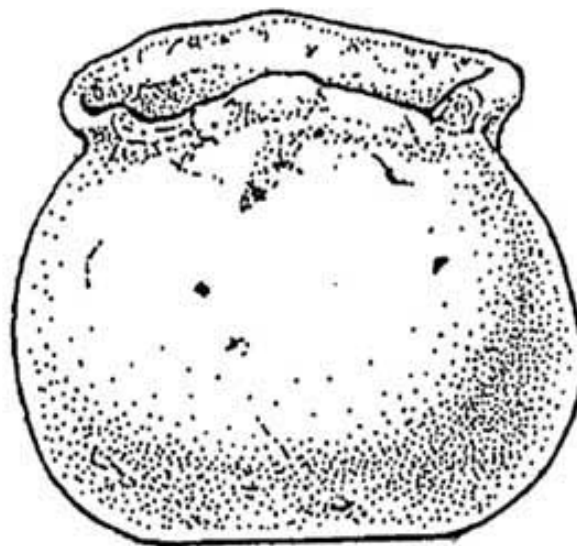
CUENCO MINIATURA (103 O.04.18)

Figure 3b. Artifacts found in Operation 103 (drawings by Sharon Belkin).

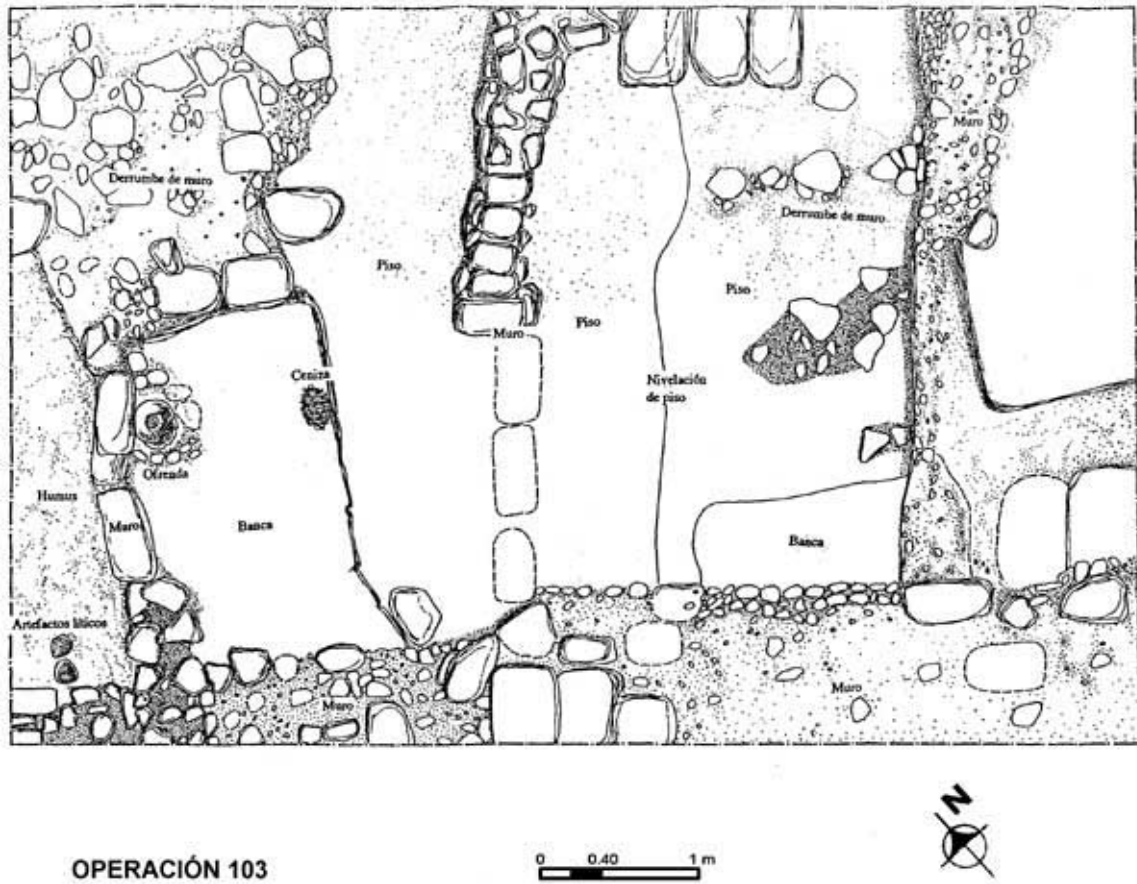
Figure 4. General plan of the excavation, showing the walls, the different floors and the leveling of the rooms' floors (drawing by A. Cajas, traced copy by E. Ortega).

Based on the excavations of Operation 103, we believe that most of the scarp was occupied by residences that were not visible, covered as they were by the heavy erosion that happened there (Figure 4). This evidence is consistent with Kevin Johnston's data from Itzan, which detected non-visible structures that represent a puzzle at the time of conducting demographic studies of Maya sites, particularly those that go very far back in time. However, the presence of residences in the scarp shows evidence of the social and demographic complexity during the Late Preclassic period at El Mirador.

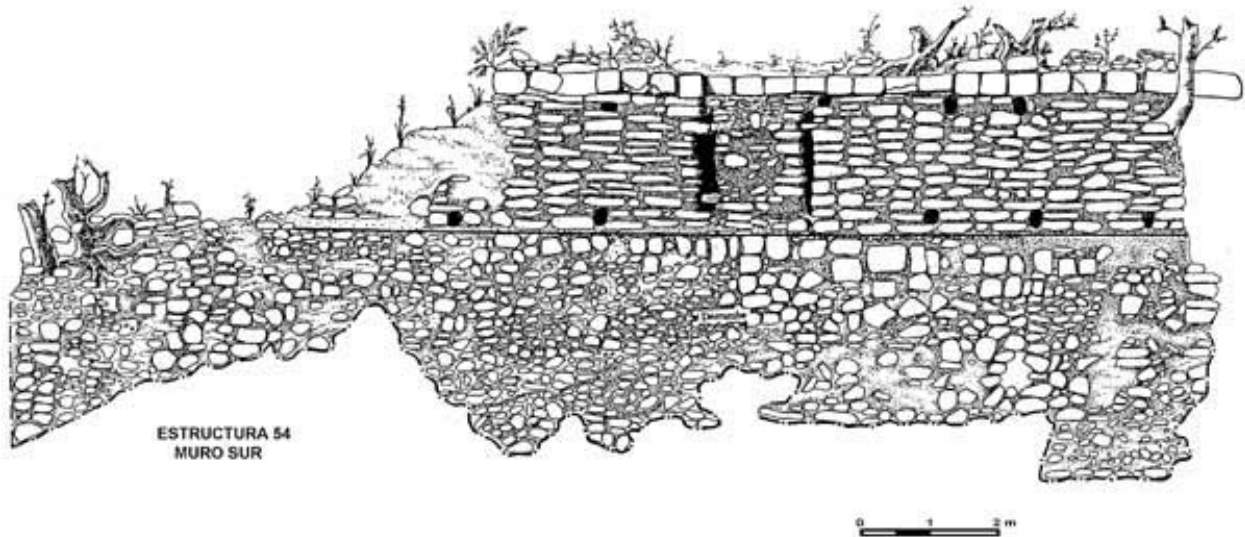
Figure 5. South wall of Structure 34, before consolidation (drawing by A. Cajas and A. Linares, traced copy by E. Ortega).

Structure 34 is a 17 m high building, and the primary structure of a construction featuring the style known as triadic pattern (Hansen 1990: 171-172); it is flanked by two smaller buildings on a common platform (Structures 33 and 35), arranged one in front of the other. Ian Graham, the archaeologist, was the first to notice the wall visible from the south side of the building (Graham 1967:45), which was preserved most probably because of the large stones of the cornice built on top (Figure 5). The dimensions of

these cornice stones are 1.05 m long, 0.40 m tall, and 0.40 m wide, and show a slight dripping carved in the lower face of the stone.

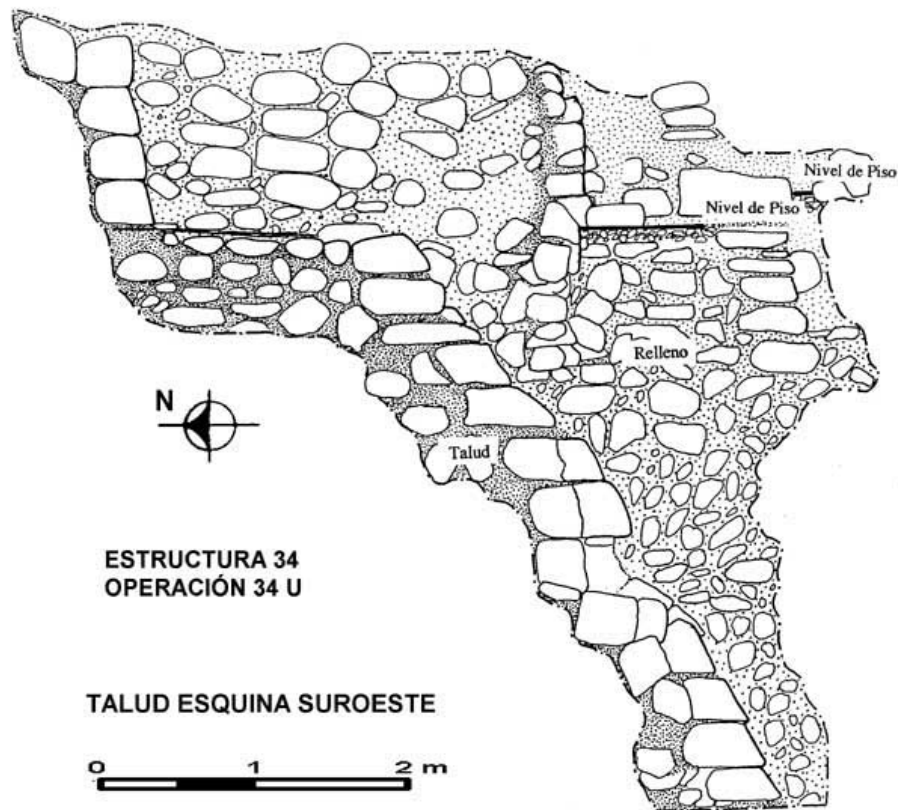
Figure 6. Drawing of the sloping wall as seen from the east (drawing by A. Linares, traced copy by E. Ortega).

New substantial discoveries saw the light during the 2003 field season in Structure 34, when the restorer Enrique Monterroso hit a previously unknown substructure (Figure 6). It was located under the chambers floors of Structure 34, and was visible from the west side of the structure only (Op. 34 U). The building exhibited a stucco floor and a strong sloping wall to the south. The modification of walls from the upper chambers saw at least three different stages, although only two were evident in the south wall. The north side wall, particularly the one on the west side, revealed three identical subsequent modifications.

The discovery of a sloping wall located in the southwest corner of Structure 34 (Figure 6) represents an interesting finding. Surprisingly, this architectural feature revealed a construction that preceded that of the chambers, but with no evidence of its presence in the tunnels and previous excavations conducted at Structure 34. This could possibly be related to the Terminal Middle Preclassic or the beginning of the Late Preclassic periods, which could eventually determine when Structure 34 was first occupied. There was no evidence of stairways corresponding to the sloping wall, suggesting that the structure underwent heavy modifications prior to the construction of the present building.

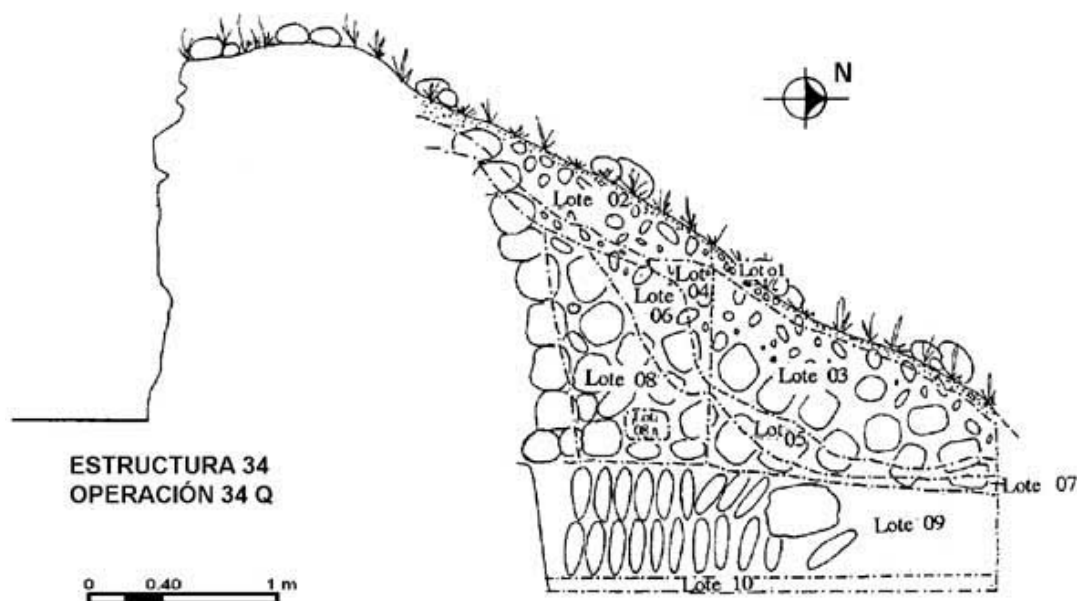
Figure 7. Operation 34 Q, showing the operation lots, as well as the collapse of the wall on top of the stucco floor (drawing by A. Linares).

Operation 34 Q was placed at the outer northwest side of the north wall of Structure 34's chambers, which had not been previously investigated. The collapse found in this operation (Figure 7) probably corresponds to a vault, as the springing is visible inside the chambers; this, however, has not made possible to determine what type of vault was used in Structure 34, as the springing continues upwards, vertically. The presence and location of the cornice in the collapsed wall of operation 34 Q, the only one found at the northwest façade of the chambers, is confusing because it was supposed not to exist. Hansen (1984, 1990) had proposed that the building was composed of a roof of beams and mortar, but not necessarily of a vault. It can be asserted that such stone is a cornice because its dimensions are similar to those mentioned by Hansen when he referred to the cornice blocks in Structure 34. However, we were unable to establish what kind of cornice the northwest façade of the chambers had, because its sides were found broken and heavily eroded.

The wall discovered in Operation 34 has the same façade –dimensions-wise- to that discovered in Operation 26 K of the excavations conducted from 1979 to 1982. Likewise, the east side of the chambers may also be compared with the inset south corner, as in the west façade of the chambers (Op. 34 Q) the well preserved corner projected itself out. The floor was found under the collapsed wall (Figure 7), showing a stucco layer applied on top of it to level the older floor. No colorant was found.

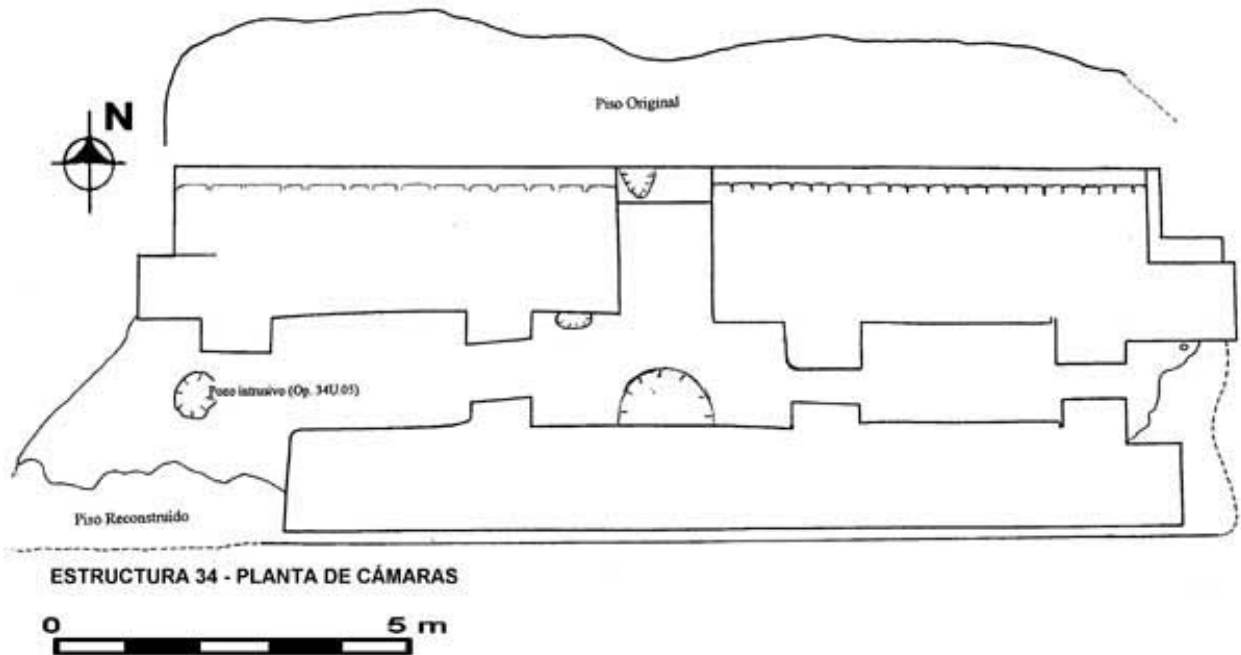
Figure 9. Final plan view of chambers. Structure 34 (drawing by A. Linares).

The five chambers of Structure 34 were intervened. A plan view was sketched to define the width of the walls, the dimensions of the chambers, as well as the restored and untouched area (Figure 9). The original stucco floor was perforated in several places in ancient times. The largest one was discovered in 1980 in the trench located at the foot of the south wall of the Central Chamber, which was full of charcoal. An additional pit found in 1980 was located in the jamb of the north wall of the Central Chamber. A floor that went unnoticed in previous excavations was located near the jamb of the north wall, at the end of the West chamber (Figure 9).
